Switchgear and Circuit Breakers Failures and Case Studies

UE Systems 2015 Reliable Asset Conference June 4th

Dan Crawford, Group Manager Field Engineering, FM Global

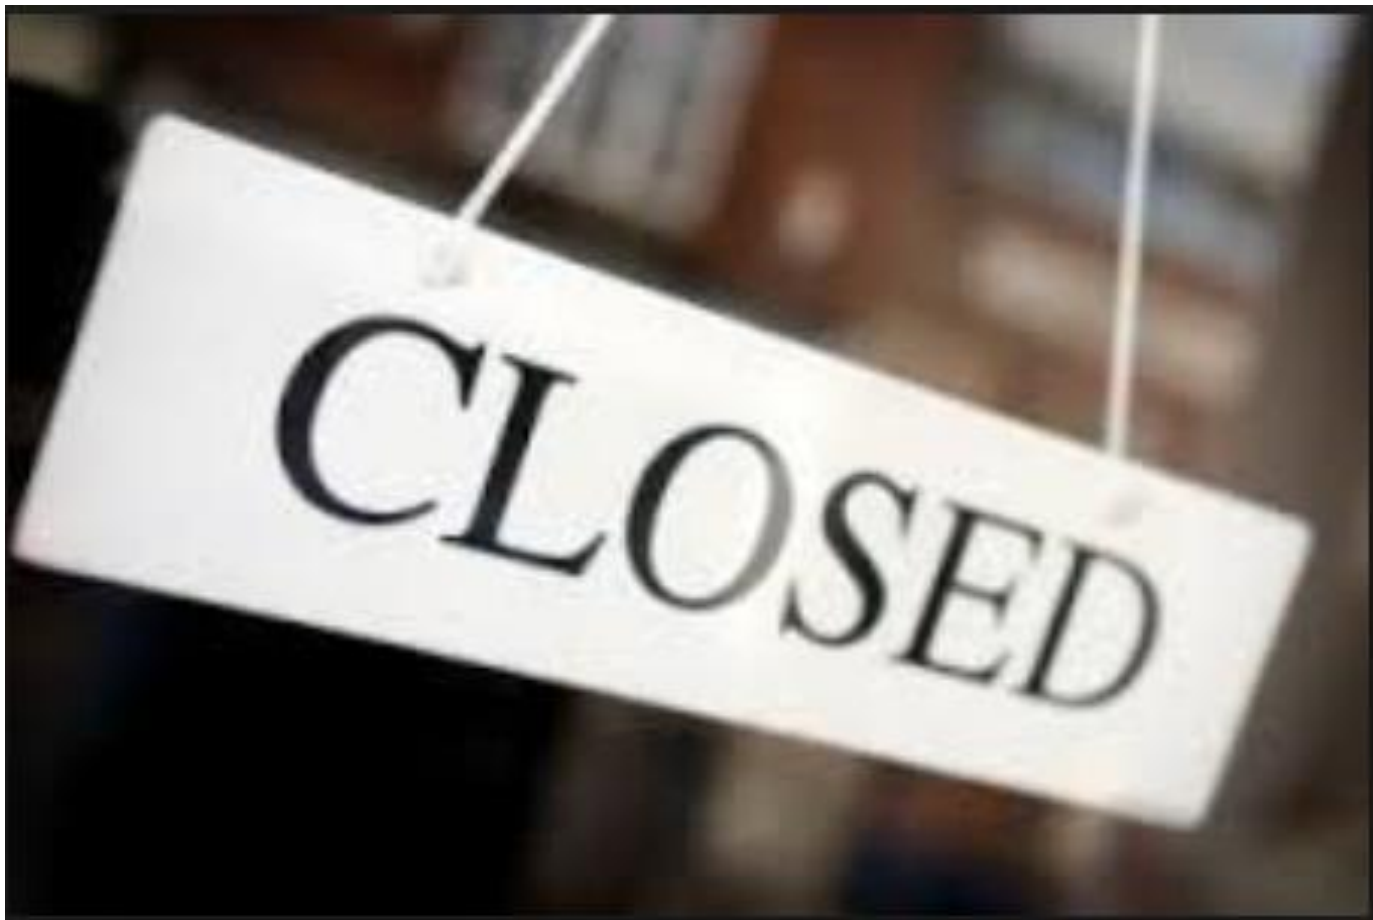
What can happen – worst case

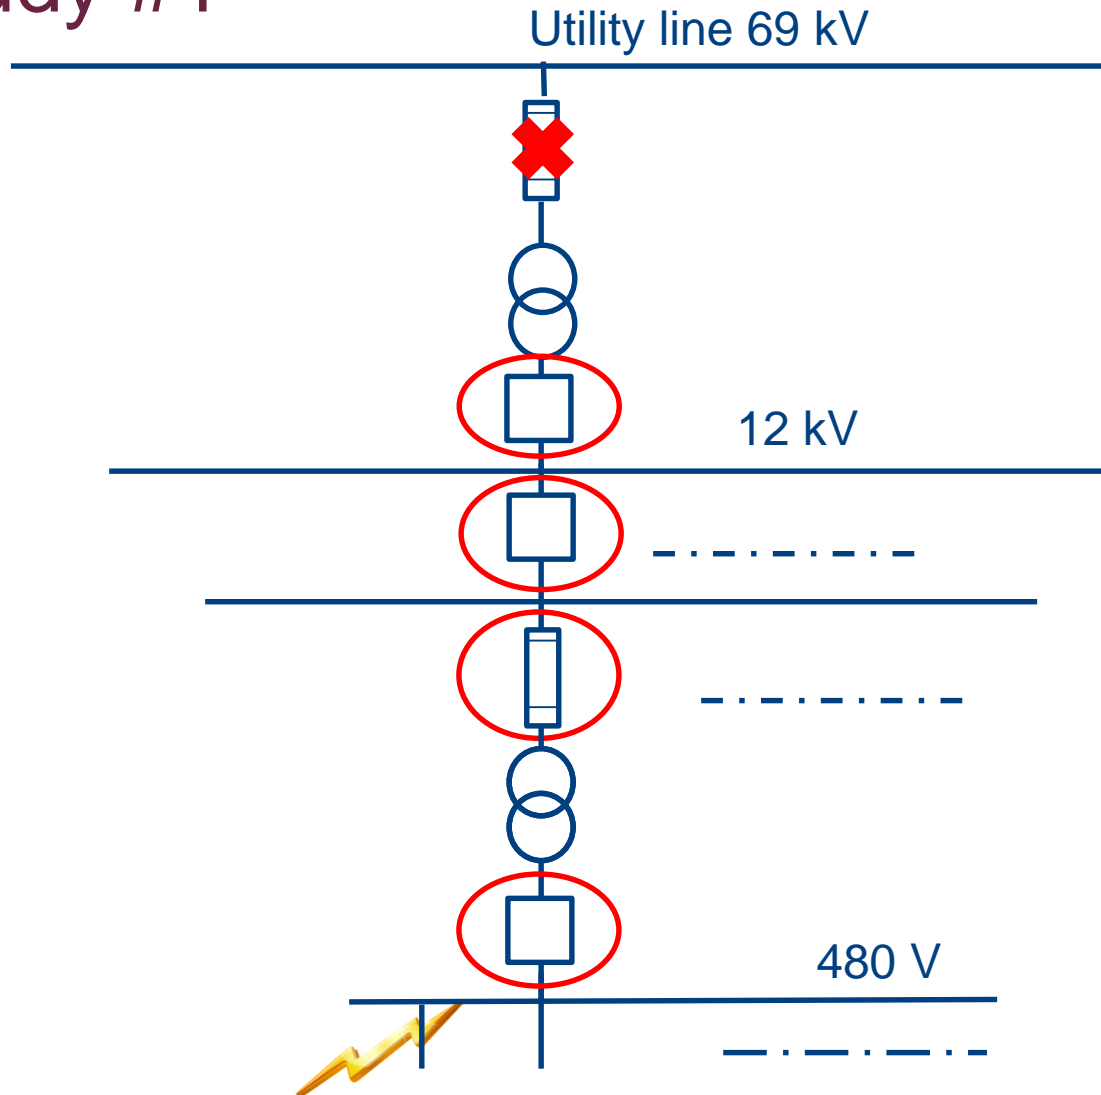
Case Study #1

- Damage Investigation
 - Explosion & fire involving 480V cabinets
 - Tank rupture of the mineral oil-filled 12 kV/480V transformer
 - Minimum business interruption: contingency plan in place

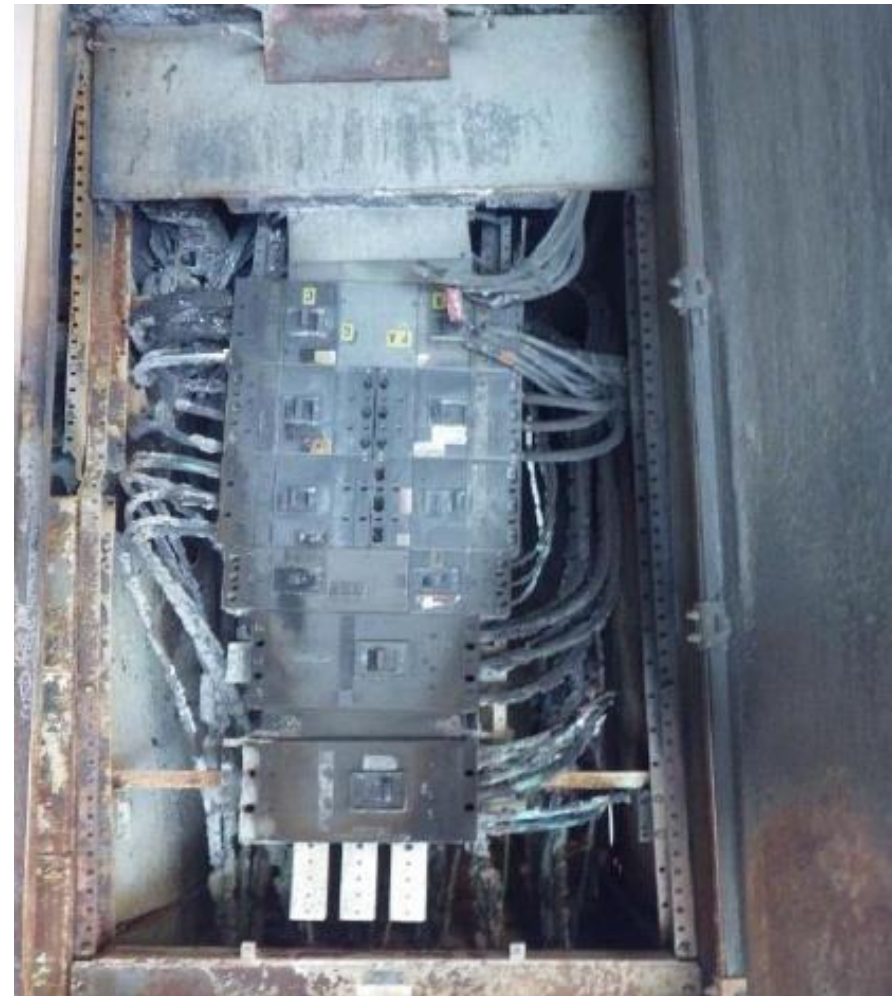
Case Study #1

- Damage investigation
 - Key contributing factor: Lack of adequate maintenance
 - 12 kV switchgear's battery - discharged
 - 480 V circuit breaker: seized
 - 12 kV fuse for transformer had a known problem

- Conclusion
 - Overall maintenance program needs improvement
 - Contingency plan minimized the BI
 - No fire following: no combustible load in the electrical room

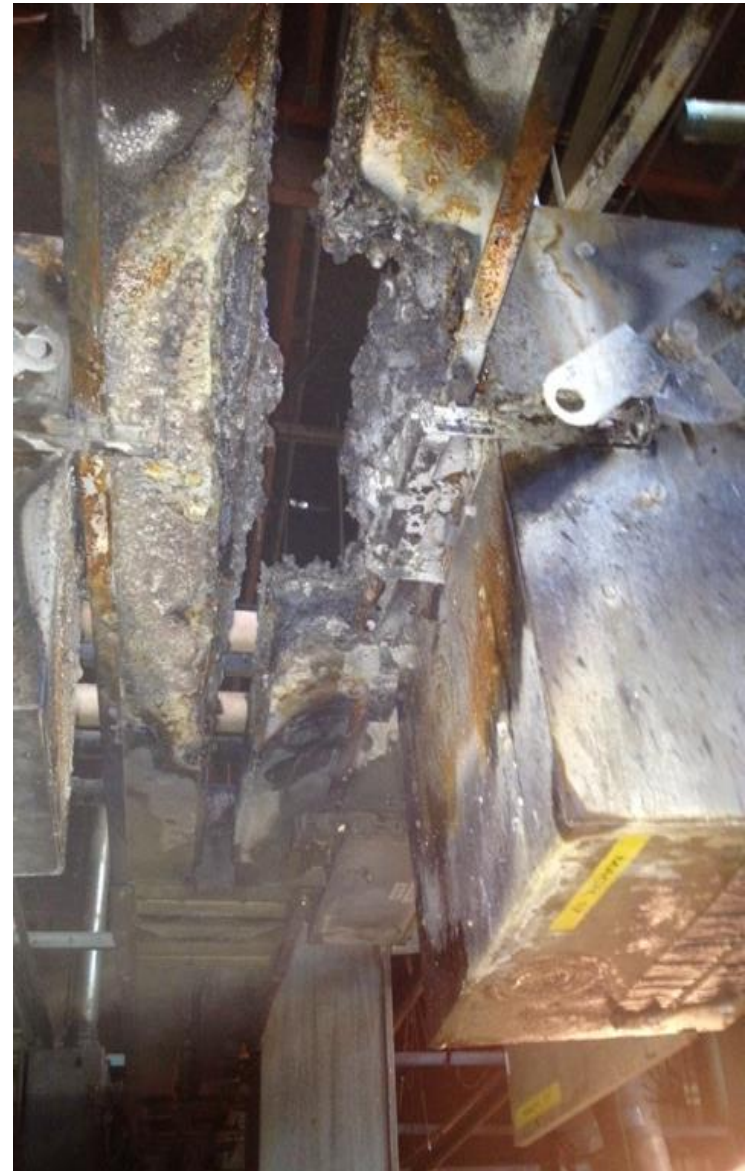
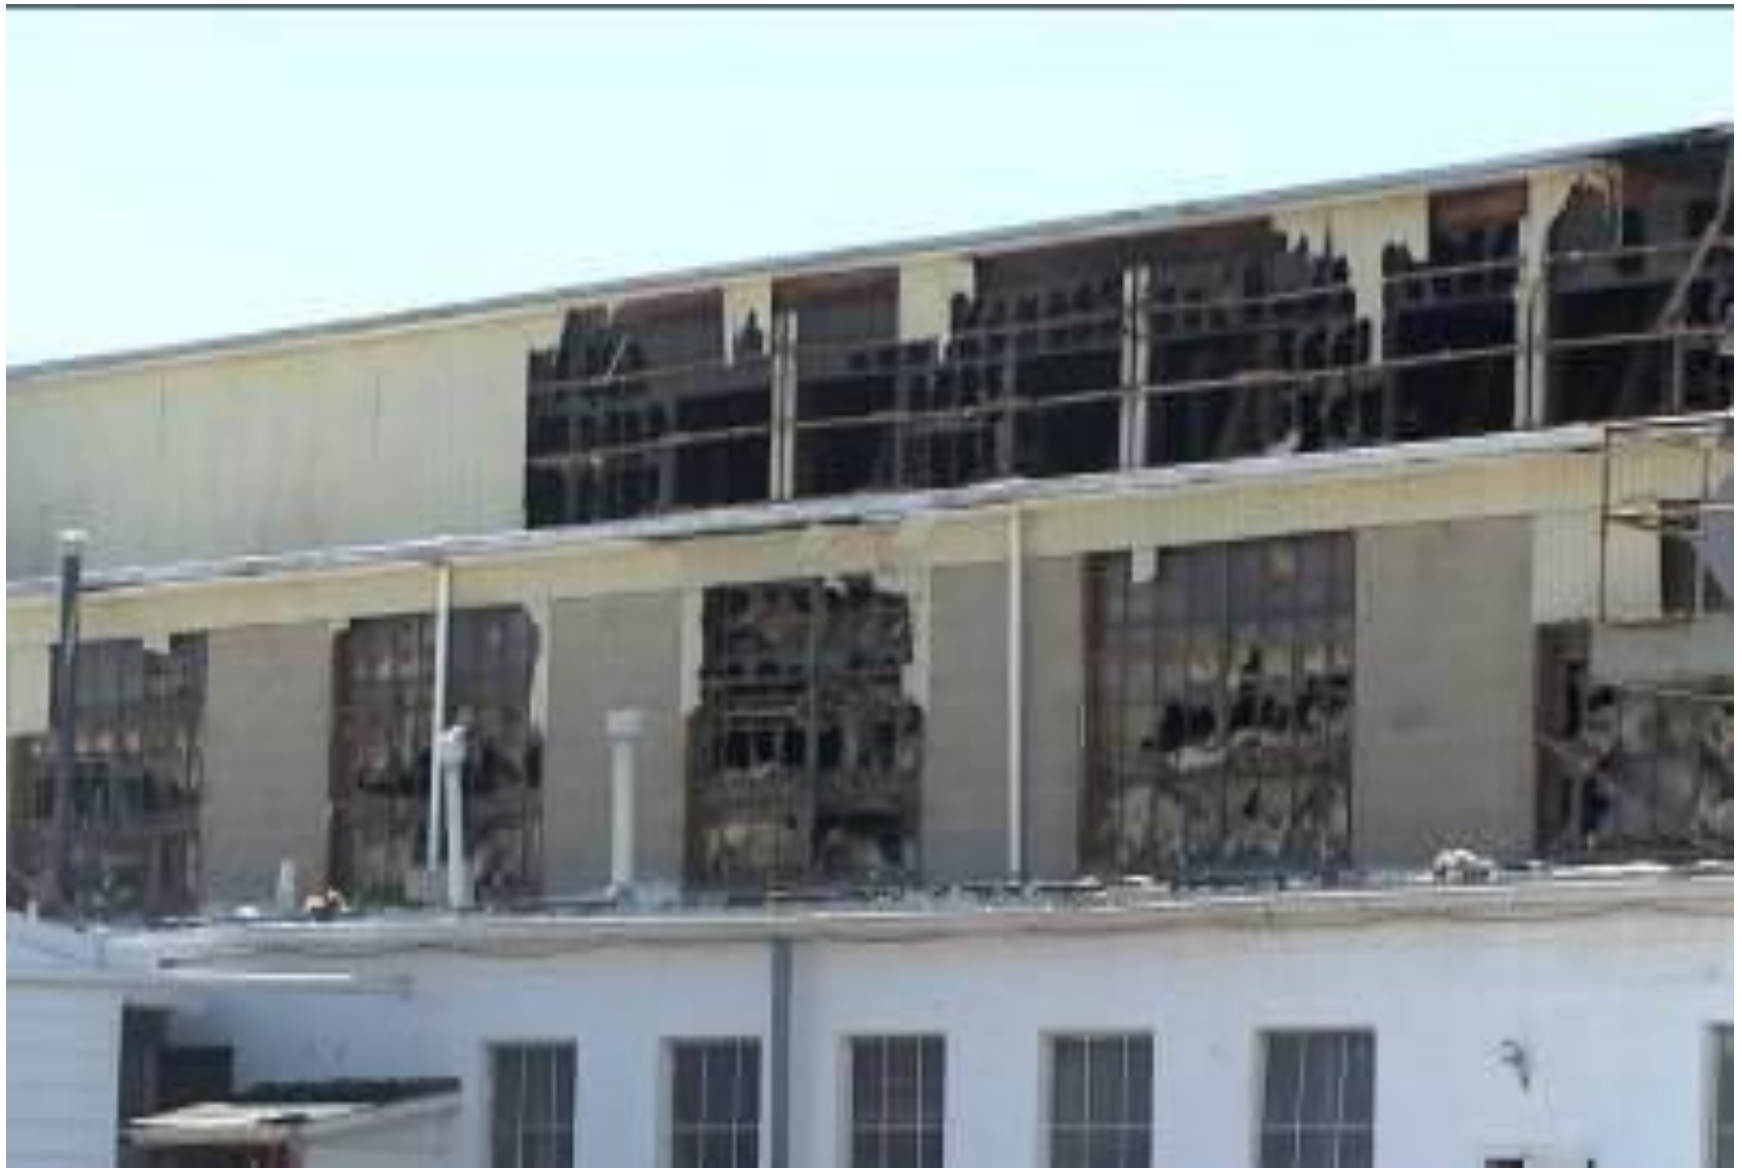
- The incident
 - Bus bar failed (close to the plug-in)
 - Aluminum bus & enclosure steel frame vaporized
 - Suspended ceiling above blew off
 - Hot particles from the bus duct explosion ignited the combustible material above the ceiling and a fire followed

- Damage investigation
 - Ground fault protection did not operate
 - Fuses of two phases melted
 - Entire bus damaged
 - Significant smoke/water damage to food product
 - 100% production shutdown

- Coordination study needed for GFP
- Test GFP during 3 year PM
- Improve bus PM
- Fire related issues
 - Automatic sprinkler installation
 - FD pre incident planning
